University of Northern Colorado DemoSat Final Report

VideoSat

PanSat

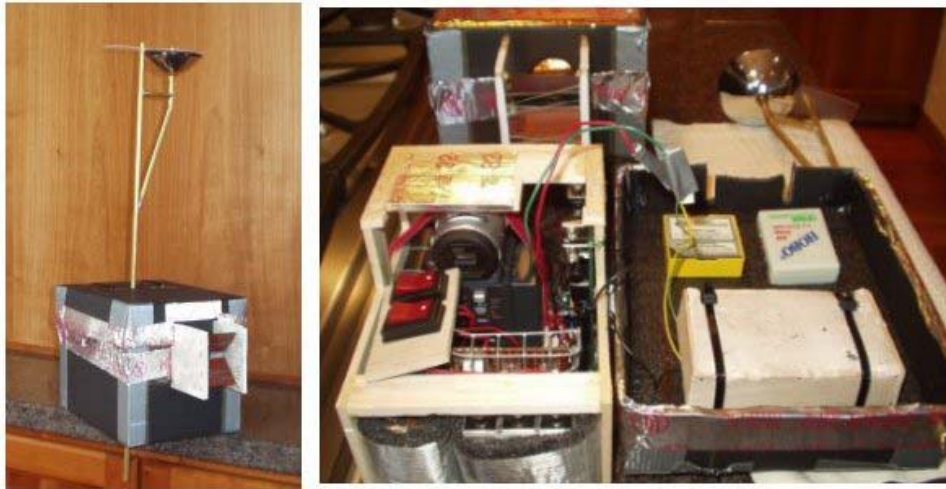
The purpose of PanSat was to obtain still panoramic images of the Earth and its horizon using a parabolic mirror during balloon ascent and descent. The Canon Elf camera and the "One Shot" parabolic dome mirror were part of a brass mount system that functioned as one unit, producing optical stability. The camera, using Kodak Advantix ASA 200 film with 40 exposures, was triggered every three minutes by a Basic Stamp. The insulated camera was mounted in the payload box lid with the lens facing upward toward the balloon. The silvered surface of the parabolic mirror faced Earthward 20 centimeters from the camera lens. A side view of the payload box showing both mirrors for the PanSat and VideoSat payloads is shown below as well as an image of the open payload box showing both cameras, the heater circuit and both HOBO's.

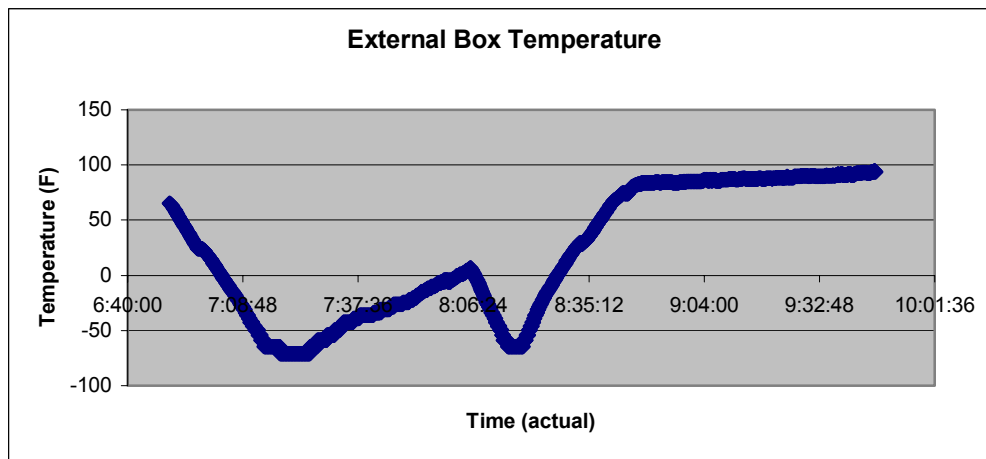
The following temperature graphs depict a basic "W" shape, meaning that the lowest temperature was reached, not at the peak, but rather at a point part way up. The payload then reached these low temperatures again when going back through this stream of cool air. The pattern can be seen in both the internal and external data. When the data is examined closely, one sees more abrupt changes in the external temperature although the basic shape of the graphs is the same. This is because the interior of the box with the heating system would take some time to equilibrate.

The goal of the UNC DemoSat group was to keep the internal temperature as high as possible, with a minimum temperature of 0° F. Although this was not obtained, the internal temperature did remain above -8.68° F throughout the duration of the experiment, while the surrounding atmosphere reached -71.26° F.

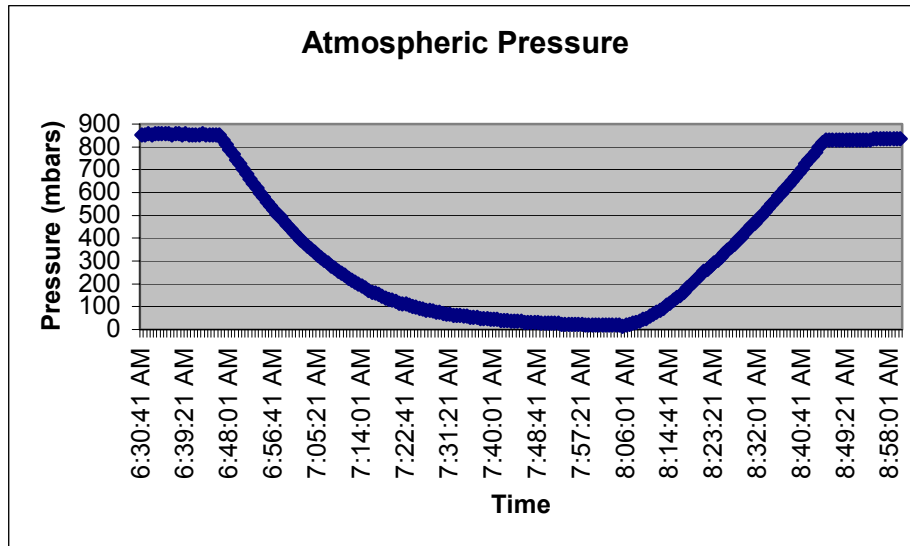
The pressure data was taken with the second HOBO. Atmospheric pressure readings were taken every 20 seconds, allowing us to make a rough approximation as to the height of the balloon. The lowest pressure reading was recorded at 8:05:21.0 am with

a reading of 14 mbar. This allowed us to establish this point at which the balloon burst with in an error of plus/minus 20 seconds.
